**DEPARTMENT OF TRANSPORTATION**

Contract #: 04-0120F4Cty: SF/ALA Rte: 80 PM: 13.2/13.9File #: 69.28**WELDING INSPECTION REPORT****Resident Engineer:** Siegenthaler, Peter**Address:** 333 Burma Road**City:** Oakland, CA 94607**Report No:** WIR-019094**Date Inspected:** 02-Jan-2011**Project Name:** SAS Superstructure**OSM Arrival Time:** 700**Prime Contractor:** American Bridge/Fluor Enterprises, a JV**OSM Departure Time:** 1900**Contractor:** Zhenhua Port Machinery Company, Ltd (ZPMC), Changxing Island **Location:** Shanghai, China**CWI Name:** Lv Li Qing**CWI Present:** Yes No**Inspected CWI report:** Yes No N/A**Rod Oven in Use:** Yes No N/A**Electrode to specification:** Yes No N/A**Weld Procedures Followed:** Yes No N/A**Qualified Welders:** Yes No N/A**Verified Joint Fit-up:** Yes No N/A**Approved Drawings:** Yes No N/A**Approved WPS:** Yes No N/A**Delayed / Cancelled:** Yes No N/A**Bridge No:** 34-0006**Component:** OBG**Summary of Items Observed:**

## WELDING INSPECTION REPORT

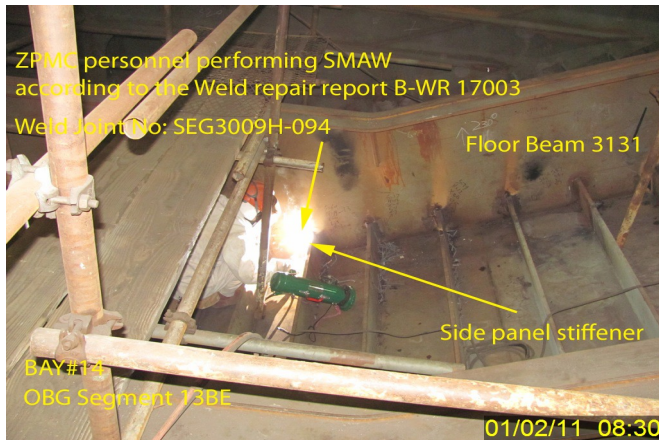
SMAW welding of weld joint no: SEG3009H-094 located on OBG Segment 13BE Floor Beam to Side panel stiffener. Welder is identified as #069683. ZPMC CWI is identified as Mr.Lv Li Qing. Welding was performed according to the weld repair report B-WR17003. The welding variables recorded by QC appeared to comply with the WPS-345-SMAW-3G(3F)-FCM-Repair-1. Please see the attached picture.

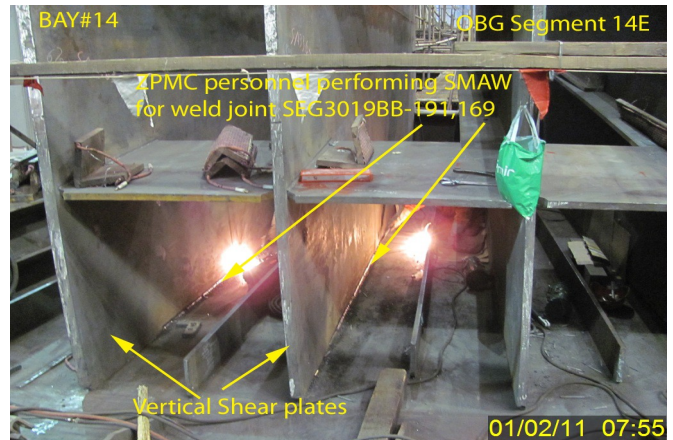
SMAW in the 2G position for the OBG Segment 14E Vertical Shear plate to Bottom plate. The weld joint was designated as: SEG3019BB-191. The welder is identified as #201087. ZPMC QC is identified as Mr. Zhong Guo Hui. The welding variables recorded by QC appear to comply with WPS-B-P-2212-TC-U4B-FCM-1. Please see the attached picture.

SMAW in the 2G position for the OBG Segment 14E Vertical Shear plate to Bottom plate. The weld joint was designated as: SEG3019BB-169. The welder is identified as #048047. ZPMC QC is identified as Mr. Zhong Guo Hui. The welding variables recorded by QC appear to comply with WPS-B-P-2212-TC-U4B-FCM-1. Please see the attached picture.
